UNITED STATES DISTRICT COURT  
DISTRICT OF MINNESOTA

Engineering & Construction Innovations,  
Inc.,

**FINDINGS OF FACT AND  
CONCLUSIONS OF LAW**

### The 10th Avenue Water Main River Crossing Project<sup>2</sup>

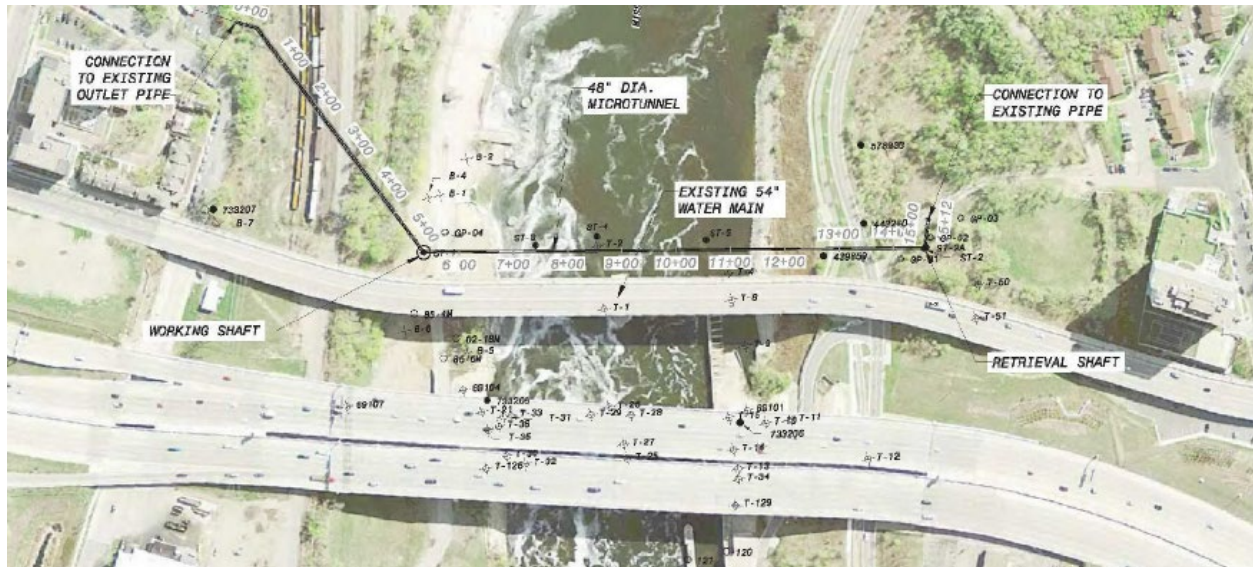
J-3 at (Figure 1) 22; J-2 at 10 (cross-section schematic).

37. The picture below shows an aerial view of the Project site, including I-35W, the University of Minnesota’s main campus (the “East Bank”), and the University of Minnesota’s west-bank campus (the “West Bank”). Tr. 62:4–20 (Johnson). The picture is marked with the launch shaft (called the working shaft in the photo) on the left, a black line representing where the steel microtunnel casing will run underneath the Mississippi River, and the retrieval shaft on the right.

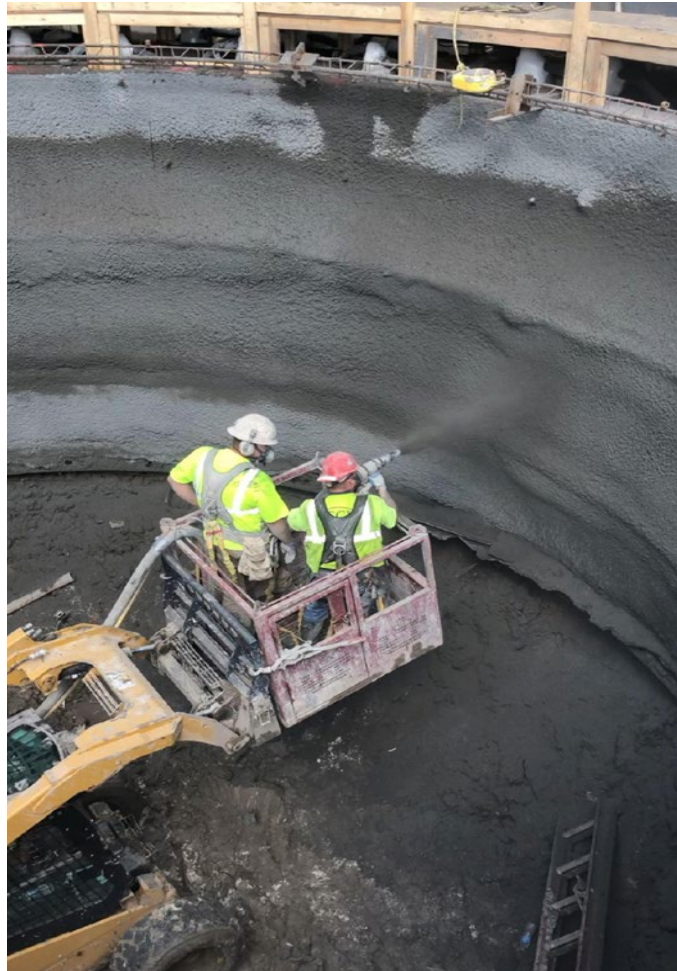
D-407; *see also* Tr. 419:24–420:3 (Marshall) (discussing D-407).

90. The photograph below shows ECI applying shotcrete to the shaft wall according to this top-down method:

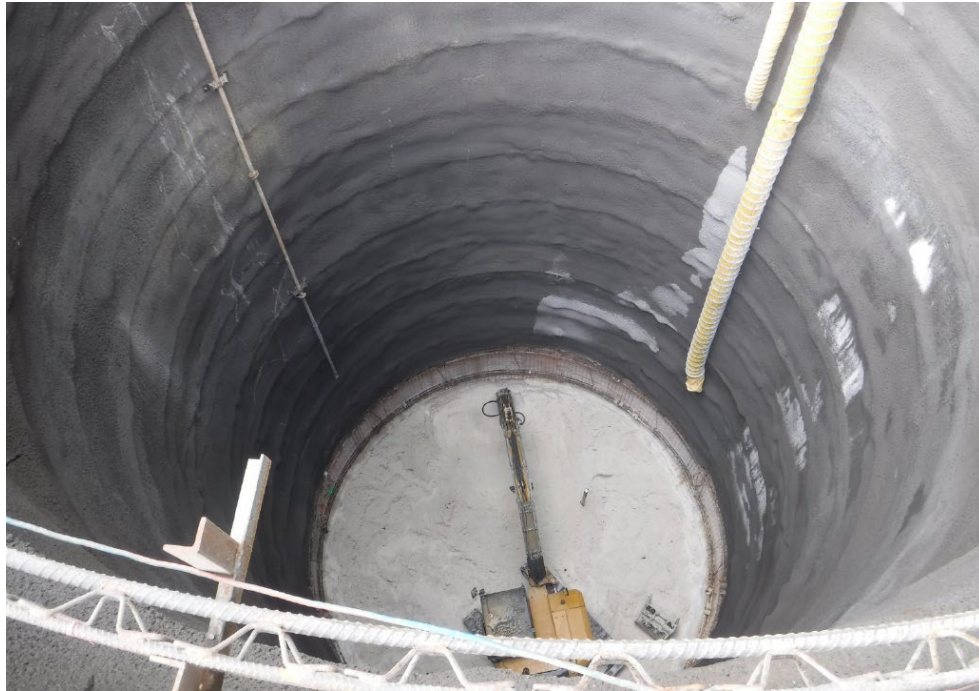
D-361; *see also* Tr. 416:22–417:5 (Marshall) (discussing D-361).

91. The photograph below depicts the launch shaft at a later stage of ECI's excavation. It shows frozen sandstone at the bottom of the shaft with reinforced shotcrete lining the shaft walls (and exposed lattice girders and welded wire fabric at the bottom):

92. From the ground surface down the first thirty feet of the launch shaft, the shotcrete was applied six to eight inches thick. Tr. 422:22–24 (Marshall). From that point down to the concrete slab at the bottom of the launch shaft—also called the concrete plug—the shotcrete was applied ten to twelve inches thick. Tr. 422:24–423:2 (Marshall). Every ECI worker who applied shotcrete was properly certified, having passed both a written test and a physical test for shotcrete application. Tr. 420:4–421:11 (Marshall).

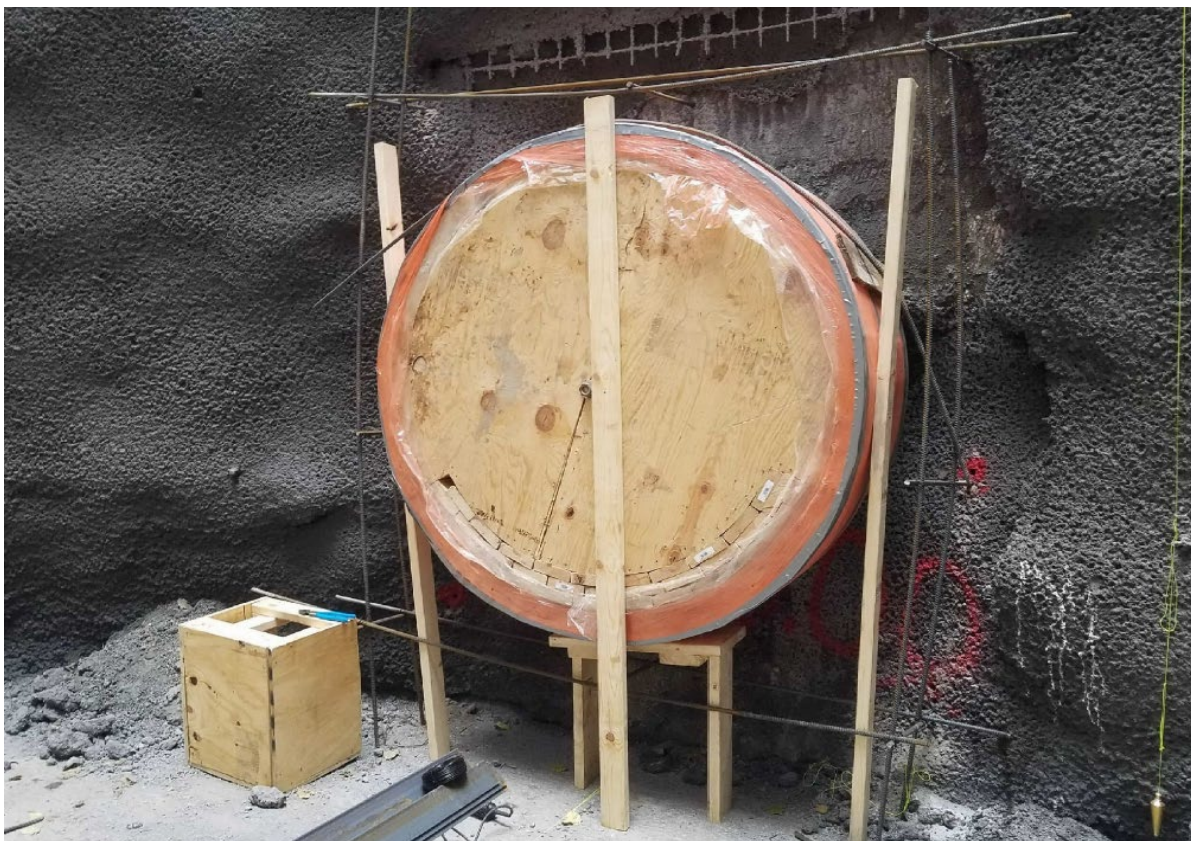
P-732.

123. During this time Bradshaw built and installed a wooden donut, also called a wooden cookie, in the launch shaft. Tr. 434:3–8 (Marshall); Tr. 1370:21–1371:3 (Wanhatalo). The wooden donut is encased in concrete and provides the space where the MTBM will go through the shaft wall and enter the subsurface. Tr. 1254:15–18 (Britton). Because the donut determines where the MTBM enters the subsurface, its placement is key to the MTBM entering the subsurface on the correct tunneling alignment. *See* Tr. 1254:23–1255:3 (Britton). The wooden donut can be seen in the following picture:

124. For context, welded wire fabric can be seen above the wooden cookie. *See Id.* The walls (darker gray with a rough texture) are shotcrete and the base of the shaft (a lighter color of gray with a smoother texture) is the concrete plug. *Id.* The metal rods around the wooden donut are rebar—metal rods placed inside concrete for reinforcement. Tr. 432:18–21 (Marshall) (describing the picture); *Rebar*, Merriam-Webster’s Collegiate Dictionary (11th ed. 2003) (“[A] steel rod with ridges for use in reinforced concrete.”). The yellow string on the right of the photograph is a plumb line; the golden cone-shaped weight on the end of the plumb line is a plumb bob.

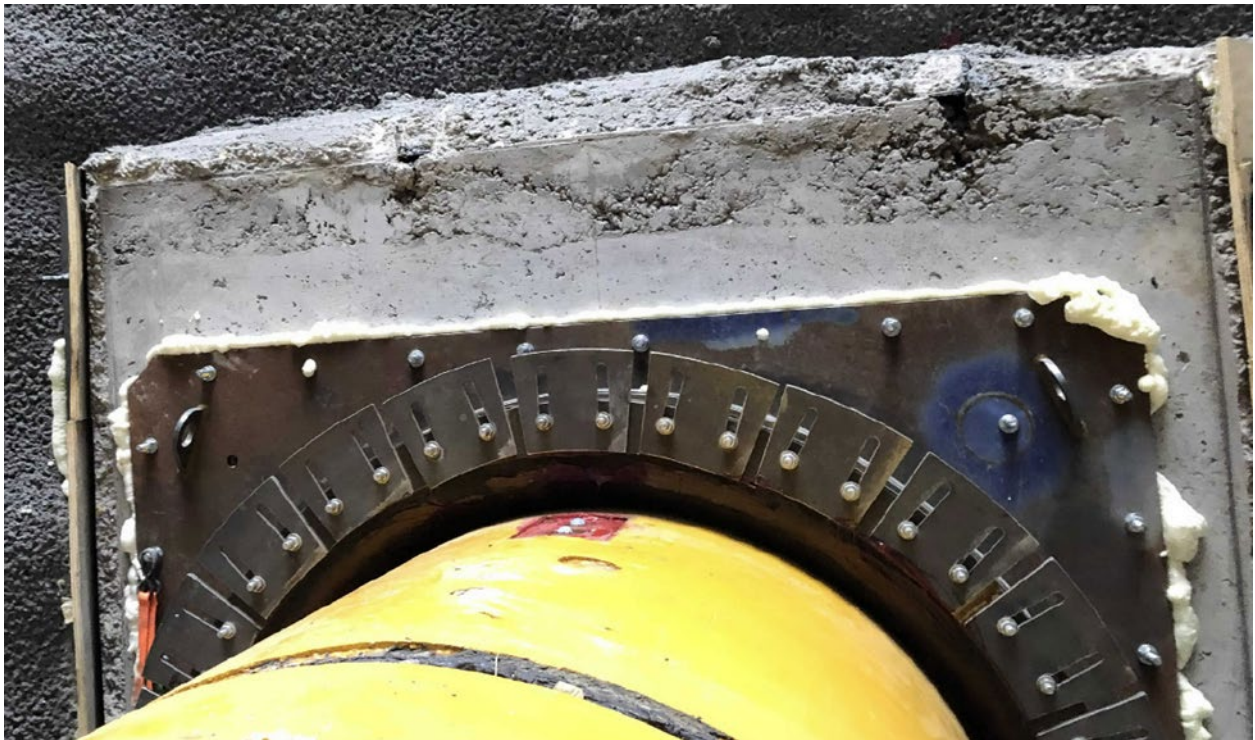
P-242 at 2; Tr. 451:7–453:11 (Marshall) (discussing P-242).

131. Inserted into the concrete as it's poured, a concrete vibrator consolidates concrete by vigorously shaking it, so that the poured concrete does not end up with voids or air pockets (a defect called honeycombing). Tr. 439:5–13 (Marshall); *see also* Tr. 93:3–11, 96:18–97:1 (Johnson).

132. Mr. Marshall offered the concrete vibrator to Mr. Short while the headwall was being poured, but Bradshaw personnel did not use it. Tr. 439:14–21, 453:12–16 (Marshall). Because a concrete vibrator was not used, portions of the headwall did not consolidate properly. Tr. 453:3–11 (Marshall). This poor consolidation can be seen in the following photograph:

165. I find that the cause of the November 7 flood event was poorly consolidated concrete. This finding is supported by the evidence of poorly consolidated concrete, P-242; Tr. 453:3–11 (Marshall); P-98 at 121, and the location of water inflows, *see* D-351; D-382. This finding is further supported by ECI and the City’s contemporaneous analysis. Tr. 88:13–90:9 (Johnson); *see also* Tr. 541:9–13 (Anderson); P-98 at 121 (“Based on my pictures it appears the headwall had I-beams placed too close to the concrete face in the member and poorly consolidated concrete.”).

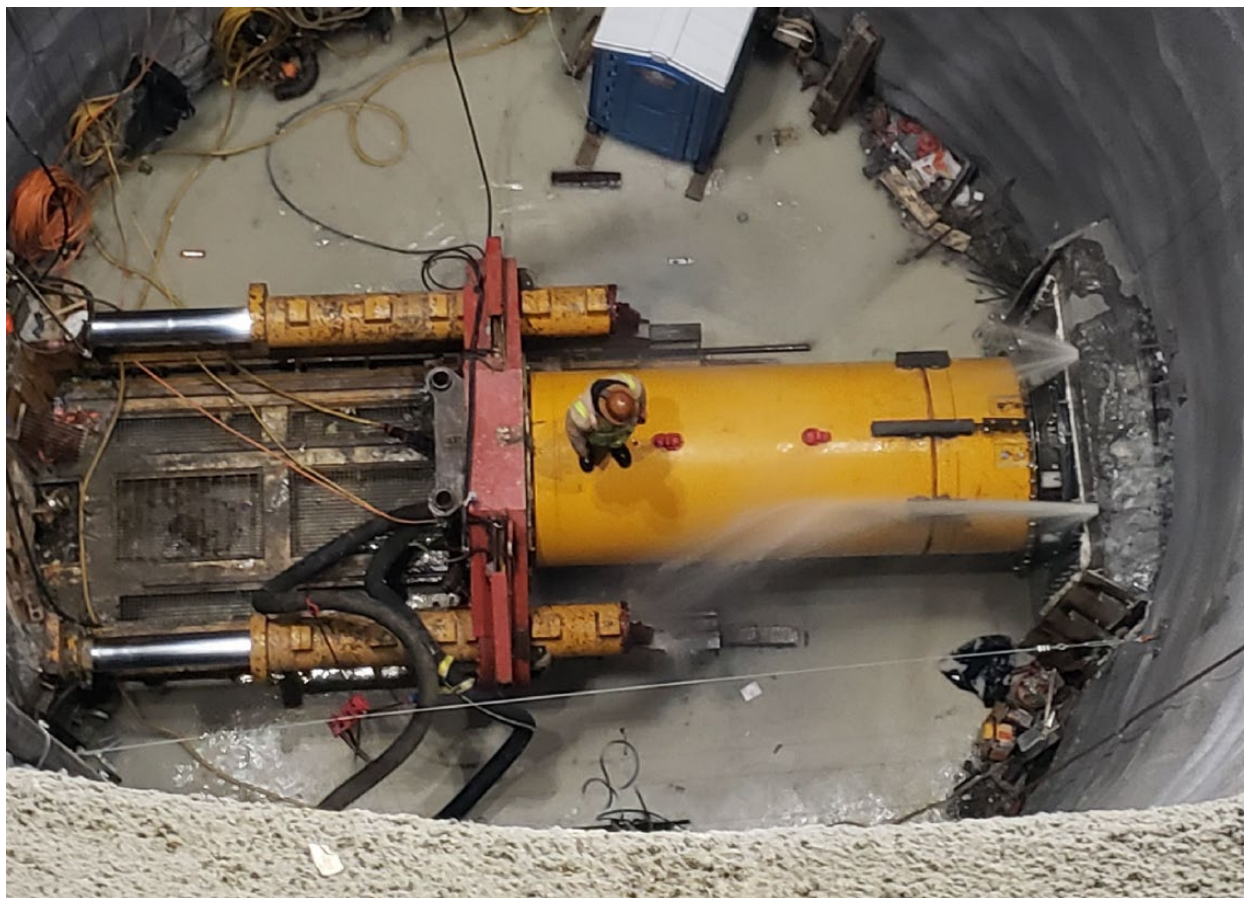
D-382.

146. Mr. Marshall went down into the launch shaft by crane in a man basket. Tr. 450:9–18 (Marshall). There were a couple of inches of water on the floor and significant amounts of water spraying from the face of the headwall into the shaft, with some minor leaks in other shaft locations. Tr. 450:21–451:3 (Marshall). He observed that the largest

inflows of water were coming through the headwall, specifically at two points where the angle irons were installed near the top of the headwall. Tr. 451:12–452:15 (Marshall).

147. The main water inflows can be seen in the following photograph:

148. Mr. Johnson and Mr. Anderson, licensed engineers, concluded based on their review of photographs that the path of the water was through the concrete headwall, along the alignment of the steel members (kickers). Tr. 88:13–90:9 (Johnson); *see also* Tr. 541:9–13 (Anderson).

150. Based on these photographs and testimony, I find that the main path of water entering the launch shaft on November 7 was through the headwall.

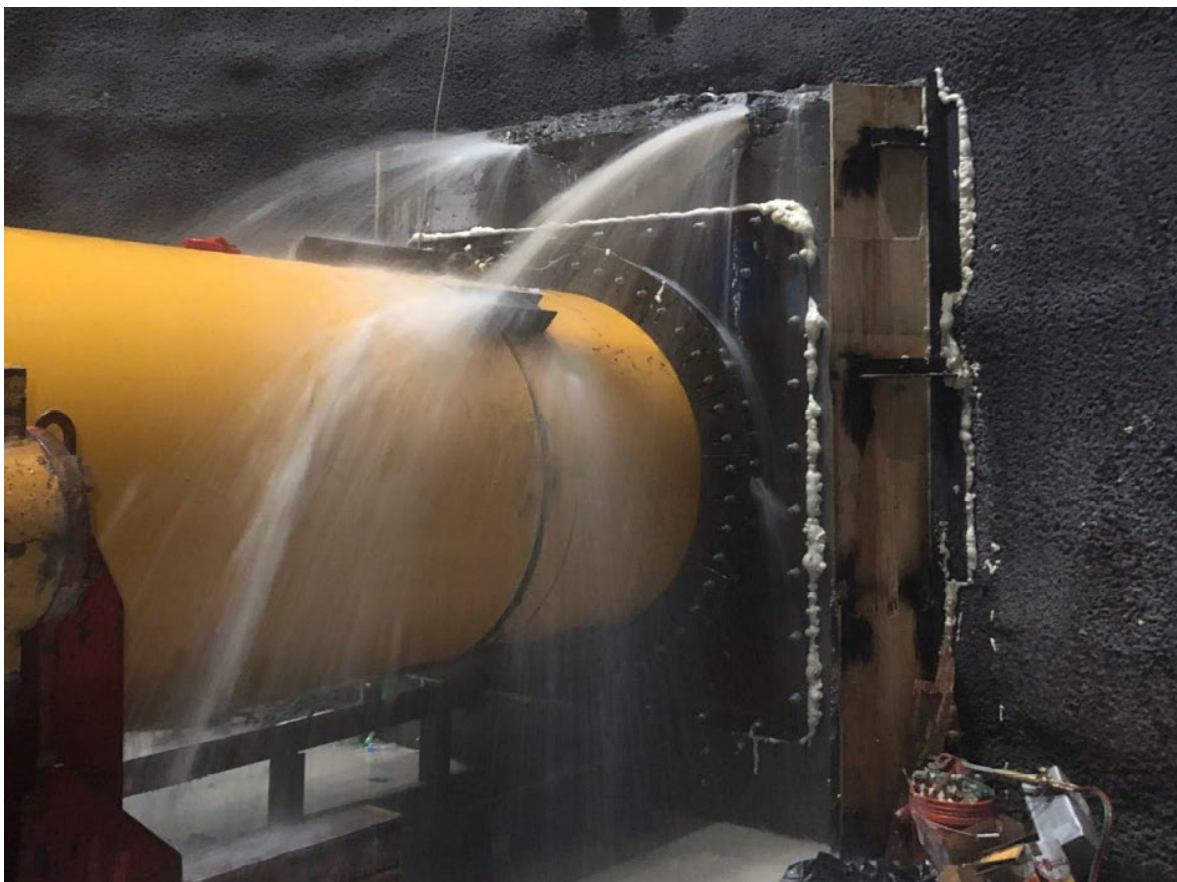
D-351.

149. A second photograph from a lower vantage point confirms that the largest inflows of water entered the shaft through the headwall:

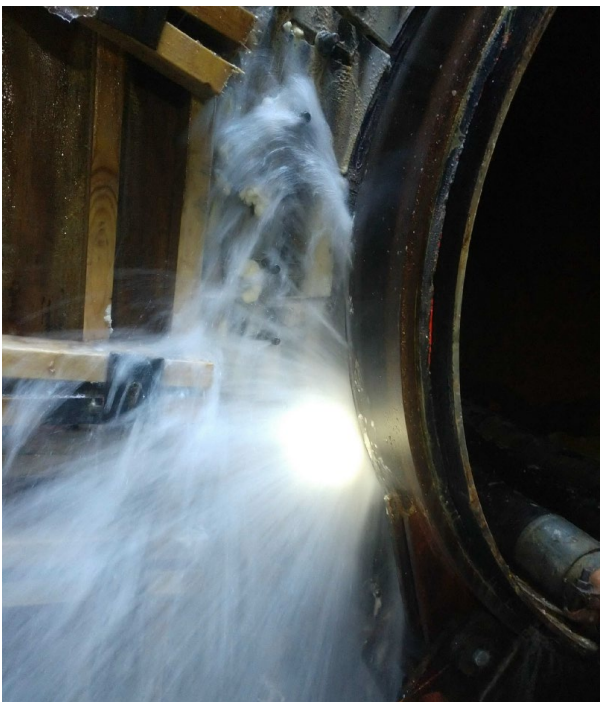
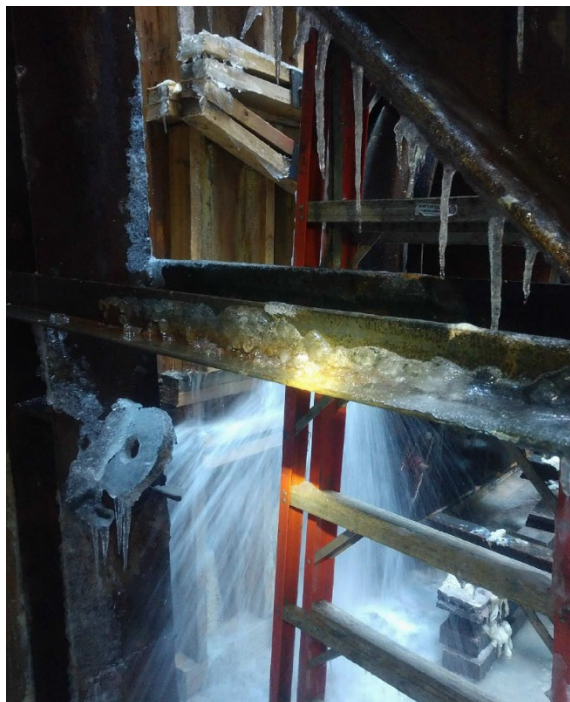
P-602 at 3; P-602 at 4.

188. Before long, water started coming in through Bradshaw's tunnel eye seal. P-602; D-386; Tr. 111:4–12 (Johnson); Tr. 356:3–13 (Umlauf); Tr. 463:7–9 (Marshall). The seal was inverting as the machine advanced, allowing water to bypass the seal and enter the launch shaft. Tr. 461:14–23 (Marshall).

189. The leaks can be seen in the following to photographs:

190. Although ECI had two pumps running, eventually the rate of water increased to a degree that ECI's pumps could not keep up. D-454 at 59; Tr. 1293:24–1294:6 (Lewis). The launch shaft was abandoned and flooded for a second time. Tr. 464:10–16 (Marshall).

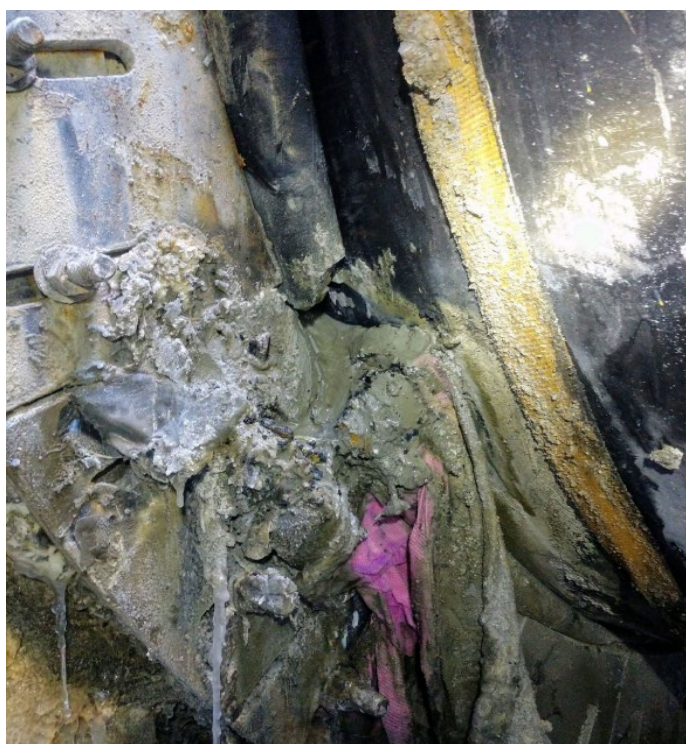
D-184 at 3.

b. Bradshaw contended at trial that ECI's grouting to remediate the November 7 flood caused the seal to fail. But there was insufficient credible, admissible evidence to support this theory. Bradshaw entered into evidence an email dated December 12, in which Mr. Umlauf wrote: "The existing rubber seal is puckered out approximately 3.5 [inches] from the face of the steel fingers." D-184 at 4. Attached to the email was the following photograph:

c. The pink is an indicator of grout. Tr. 832:6–10 (Hirner). This photograph is of the casing through the launch seal that is bolted to the headwall. *Id.* This photograph does not support Bradshaw's theory. There is no evidence in the record linking this photograph to the grouting to remediate the November 7 leak. And this photograph was sent on December 12—after grouting efforts to remediate
